# CRANDON LAKE DAM NJ 00267

PHASE 1 INSPECTION REPORT  
NATIONAL DAM SAFETY PROGRAM

May, 1979

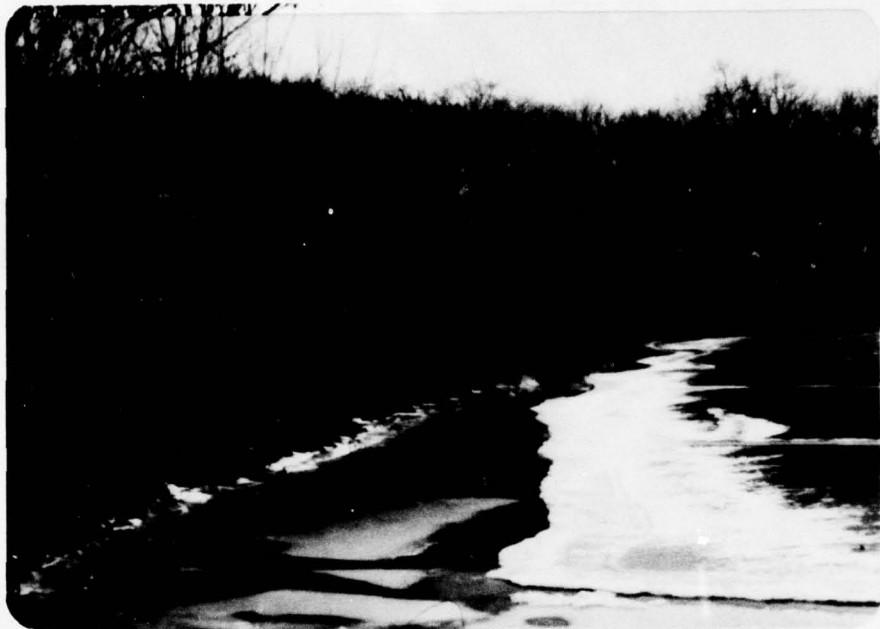
Upstream face of dam. Looking west.

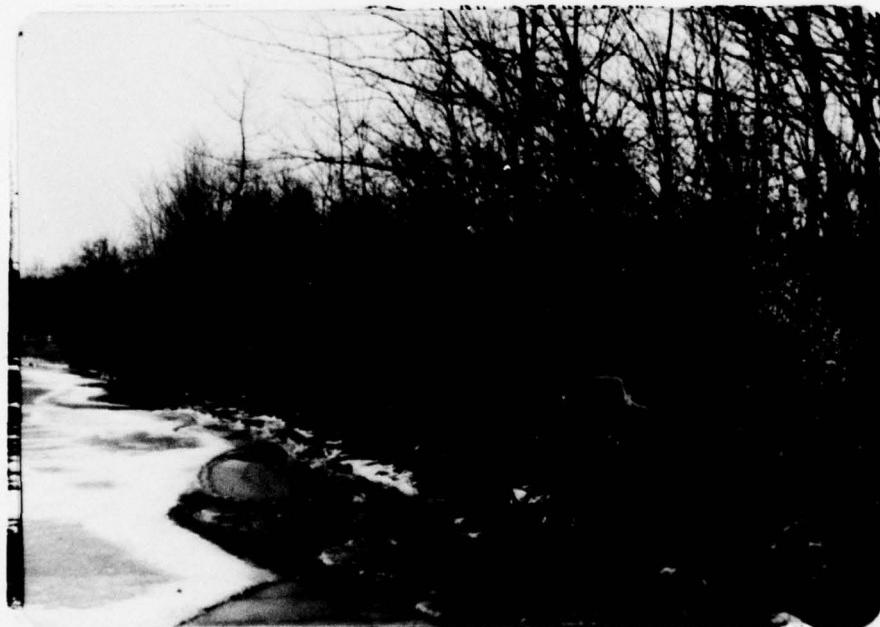
Upstream face of dam. Looking east.

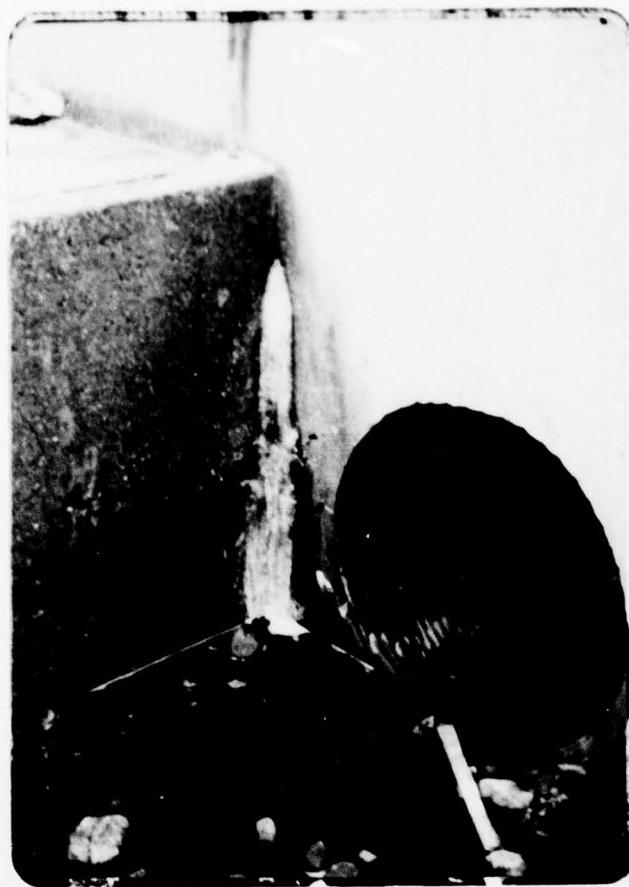
The drop-box spillway structure has a few localized spalled areas and surface deterioration. Small seepage was observed at the left corner abutting the headwall for the outlet conduits.

Water seeping at joint at left wall of drop box spillway.

5. Eroded areas of the dam should be suitably backfilled and measures taken to prevent future erosion. This should be done soon.
6. Repair leaks in the drop-box spillway. This should be done in the near future.

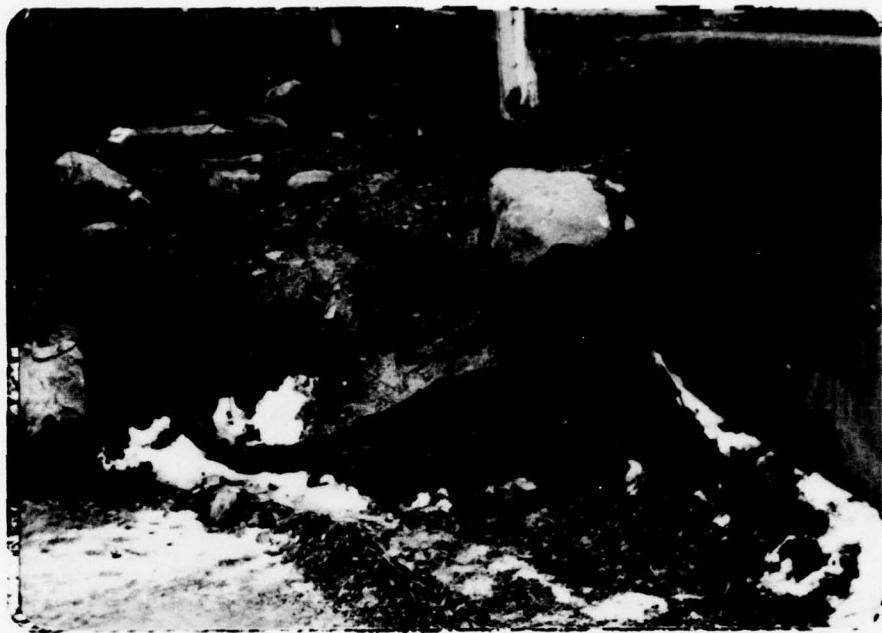
Erosion at left spillway/embankment junction.

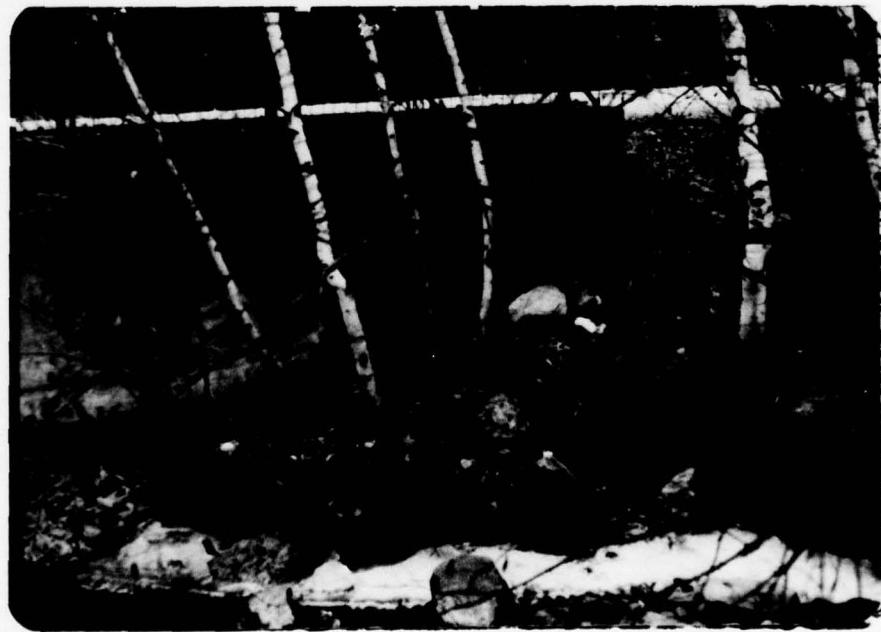
Erosion at right spillway/embankment junction.

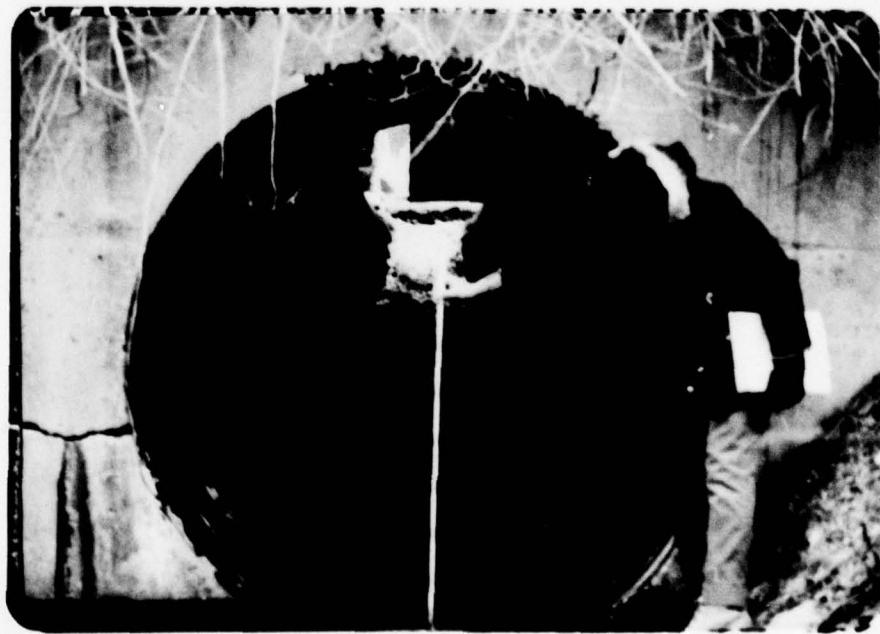
The two 6-ft-dia spillway outlet pipes and the 3-ft-dia low level outlet pipe have rusted over the lower portion of their circumferences.

Left spillway outlet conduit.

1. Replace or reline the two CM pipes passing through the dam. This should be done soon.
2. Repair and, if necessary, strengthen the concrete headwalls for the box spillway and the discharge pipes. This should be done soon.

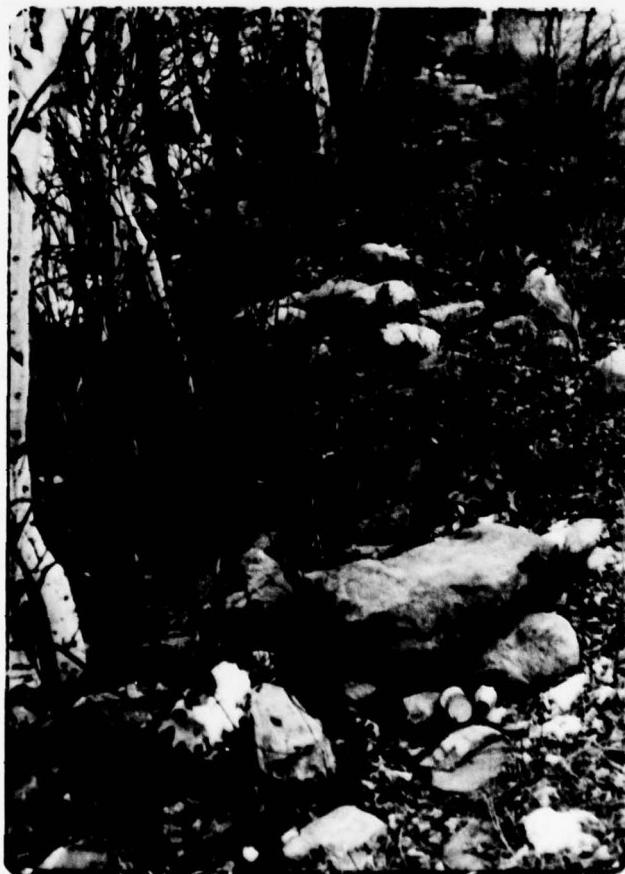
The alignment of the embankment and its junction with the abutments appeared satisfactory. No noticeable seepage or leakage was observed. Both slopes of the embankment are overgrown with small to medium size trees and bushes. Erosion was observed along the sides of the downstream headwalls for the outlet conduits. Some erosion was also observed on upstream slope near the drop-box structure and at a few other locations.

Debris, riprap and trees on  
upstream face of dam.

3. Remove all trees from the area of the dam. This should be done soon.
4. Investigation should be conducted to locate the inlet of the 36-in-dia blow-off pipe and to determine the existence and operating condition of its gate. This should be done soon.
